Monitoring Data Record

Project Title: B-3126 (Br. #90 over Gunpowder Creek on SR 1718)
 COE Action ID: 2007-1591-214 DWQ Number: 070583
 Stream Name: Tributary to Gunpowder Creek
 City, County and other Location Information: Caldwell County, Bridge #90 over
Gunpowder Creek on SR 1718(Deal Mill Road) near Granite Falls..
 Date Construction Completed: 3/11/09 Monitoring Year: (3) of 5
 Ecoregion: _____ 8 digit HUC unit 03050101
 USGS Quad Name and Coordinates: Granite Falls N 35.84415, W 81.43603

Tributary to Gunpowder Creek

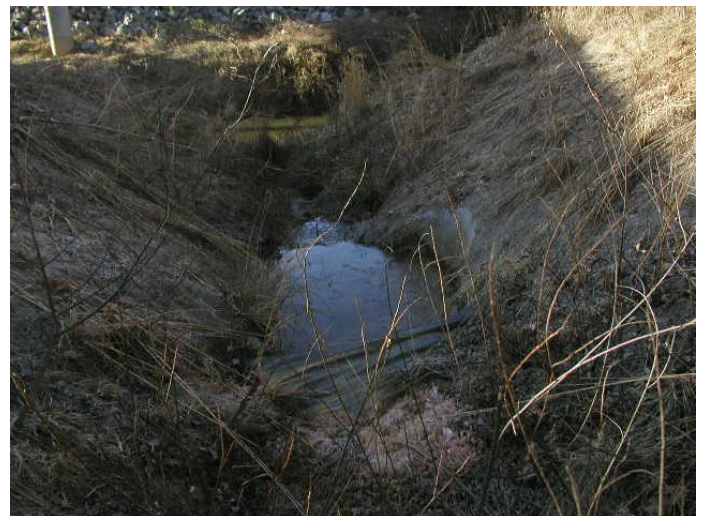
Photo Point #3 (Downstream)

The left buffer downstream of photo point #3 has been mowed.

Estimated causes, and proposed/required remedial action: NCDOT replanted the left buffer area on February 17, 2011. NCDOT also installed a sign indicating a mitigation site area to prevent further site disturbance.

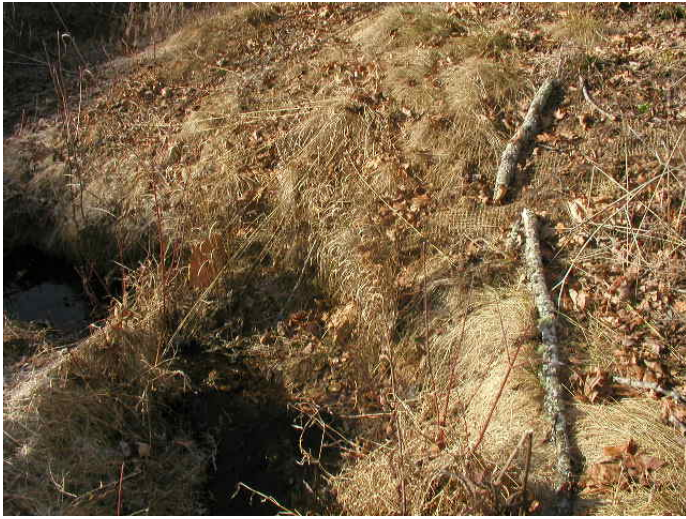
This is the Year 3 winter evaluation for the Tributary to Gunpowder Creek. The minor bank scouring along the right bank at Sta. 0+90 has seen little or no change since the last evaluation. There were three crossvanes that had water piping under them within the step pool area noted during this evaluation, however, it is not affecting the overall stability of the stream at this time. NCDOT will continue to monitor this stream relocation to see if remedial action is warranted.

Minor bank scouring along right bank @ Sta. 0+90-NSD-

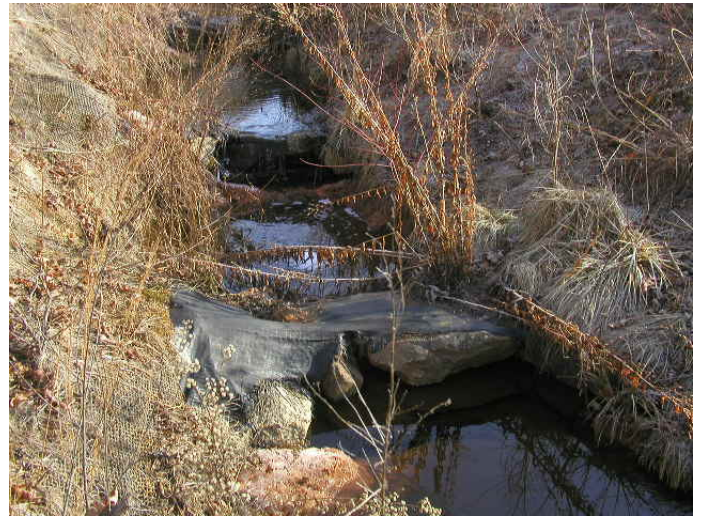
Water piping under crossvane @ Sta. 2+40-NSD-

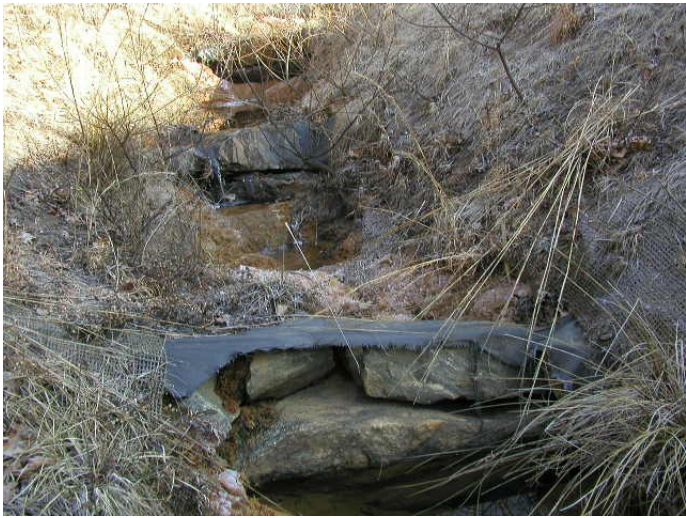
Water piping under crossvane @ Sta. 2+50-NSD-

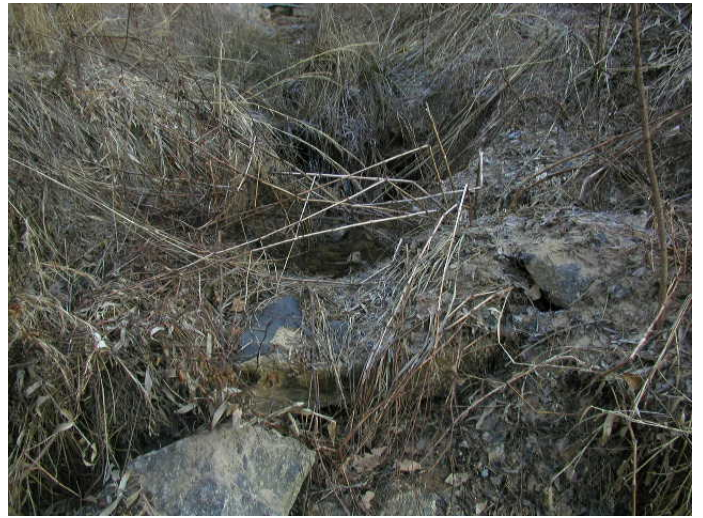
Water piping under crossvane @ Sta. 3+10-NSD-

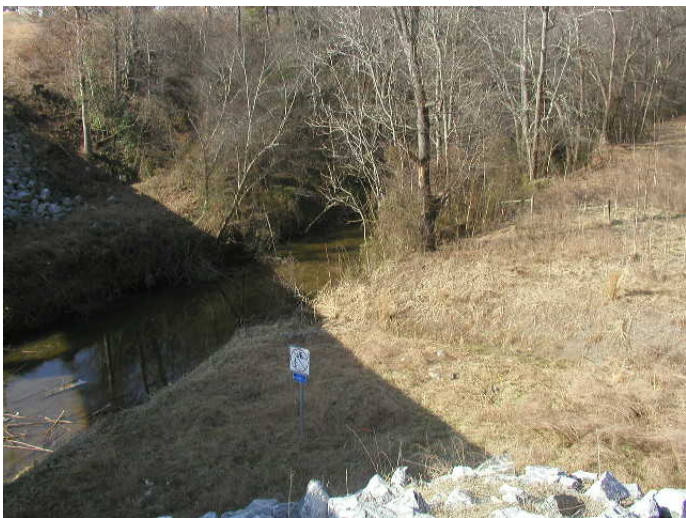
Buffer area downstream of PP#3 replanted and sign installed
